## Technical Committee – November 2007

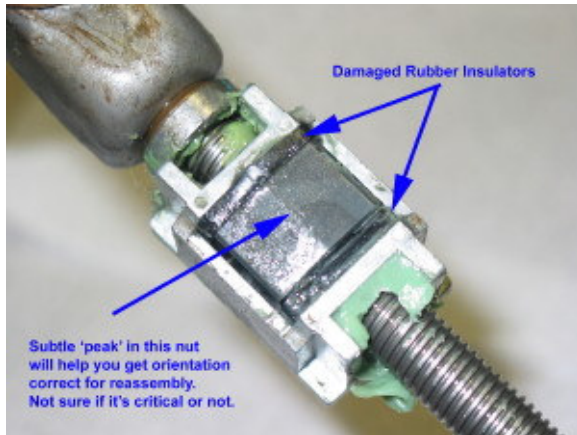
When I first became aware of the seat-rocking problem, I was told by some mechanics that the threads on the nut that ran along the screw drive rail became distorted. The rocking was supposedly due to the play between the nut and screw threads. Recently, however, Phil Hambrecht brought an article to my attention that may drastically change the outlook on this problem. The author of this Internet article claims that the rubber insulator, which surrounds the nut, wears or becomes soft. So, the seat rocks because the insulator surrounding the nut does not keep the adjuster block steady on the adjuster drive screw. I must be very clear here: **What follows is not an approved Chevrolet fix.** So, there's the standard disclaimer: **Do this at your own risk.** Also, I have no proof that the problem is actually caused by the rubber insulator as claimed by the author. It could be the nut threads after all. However, the author has claimed success and you can e-mail him to inquire about his claims. The cost for the repair is 60 cents per rail, or a \$1.20 per seat, not including labor. You heard me right, a little over a buck per seat!

Here's the nut, rubber insulator and adjuster block on the screw drive

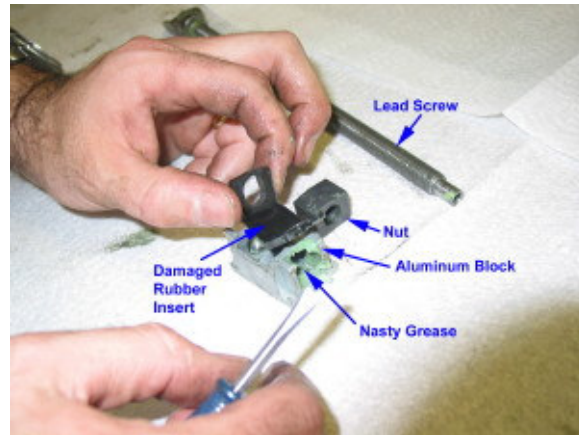
Here is the rubber insulator being removed from the block.

So, what's the fix? First, one must remove the seat from the car taking care not to scratch the paint or interior trim. Then you must remove the adjuster and disassemble both seat rails. One then removes the worn rubber insulator surrounding the nut. Two nylon washers, which can be obtained at Ace Hardware, replace the rubber insulator on both sides. The washers' edges must be shaved a bit to fit correctly on the shaft. Then the other rail is done, the adjuster reassembled and the seat placed back in the vehicle.

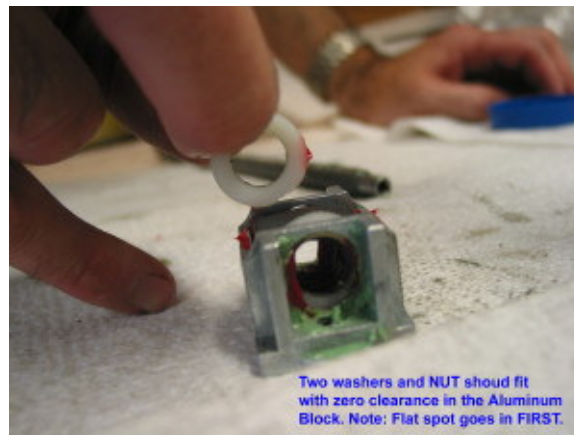
Here is one of the nylon washers that will surround the nut instead of the insulator
